Bulletin No.	R_03_2025_revC
Date	September 2025

**Kit VW T5 / T6 98655Z156 - Kit Combi Rail Bracket 98655Z147  
for F45s and F43van awnings**

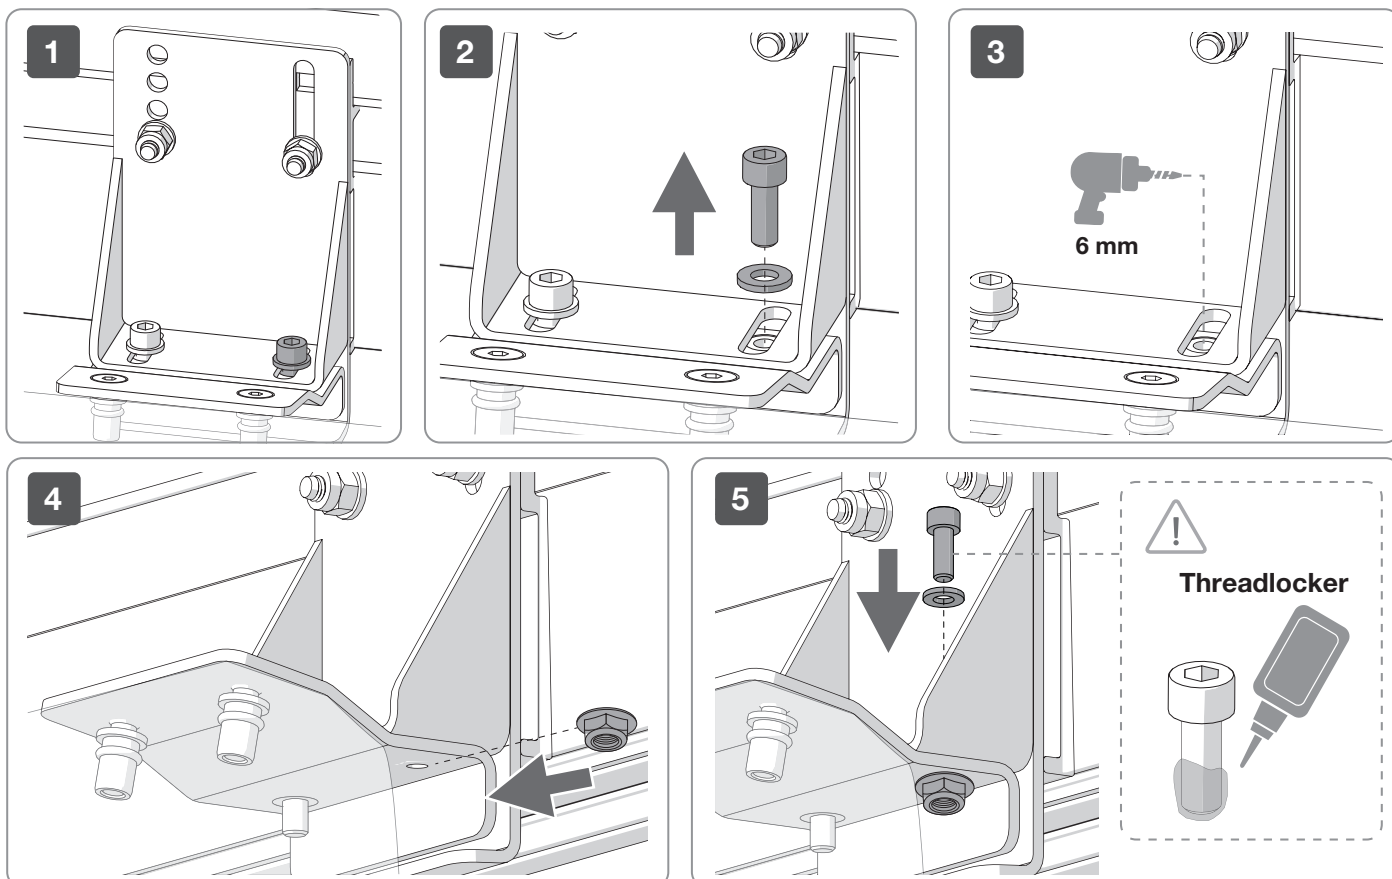
we understand a production lot of our awning brackets may have sealing issues due to a non-compliant component. In case of any loose connections between awning and vehicle, we recommend to contact your dealer to obtain a repair kit to solve your issue.

**REMOVE ONE SCREW AT A TIME, SO AS TO AVOID REMOVING THE AWNING**

**Make the modification for both front and rear bracket**

Please refer to the guide below for a step by step instruction on the solution to this problem.

Item No.	Item No. - Security kit
Kit VW T5 / T6 Multirail Reimo	98655Z156	98673-378
Kit Combi Rail Bracket	98655Z147

4x
